# Stream Assessment Report

FOR THE PROPOSED DEVELOPMENT AT 6 TEITEI DRIVE OHAKUNE

GILES TAIT - KĀINGA ORA – HOMES AND COMMUNITIES

15 JUNE 2023

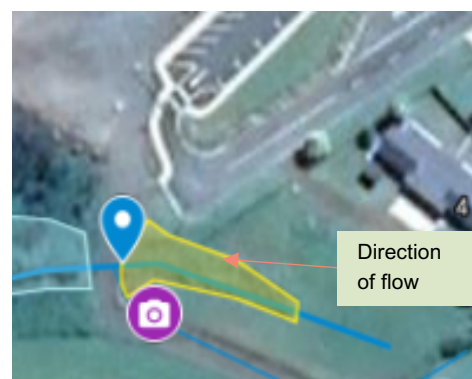
- Water is held up here and over a period of time, seems to have formed a small boggy area with typically water or 'wet feet' tolerant plants such as *Ranunculus* (buttercup). This is shown in Figure 8 as a small yellow polygon.

Figure 8 – Zoomed-in map view of ephemeral wet area

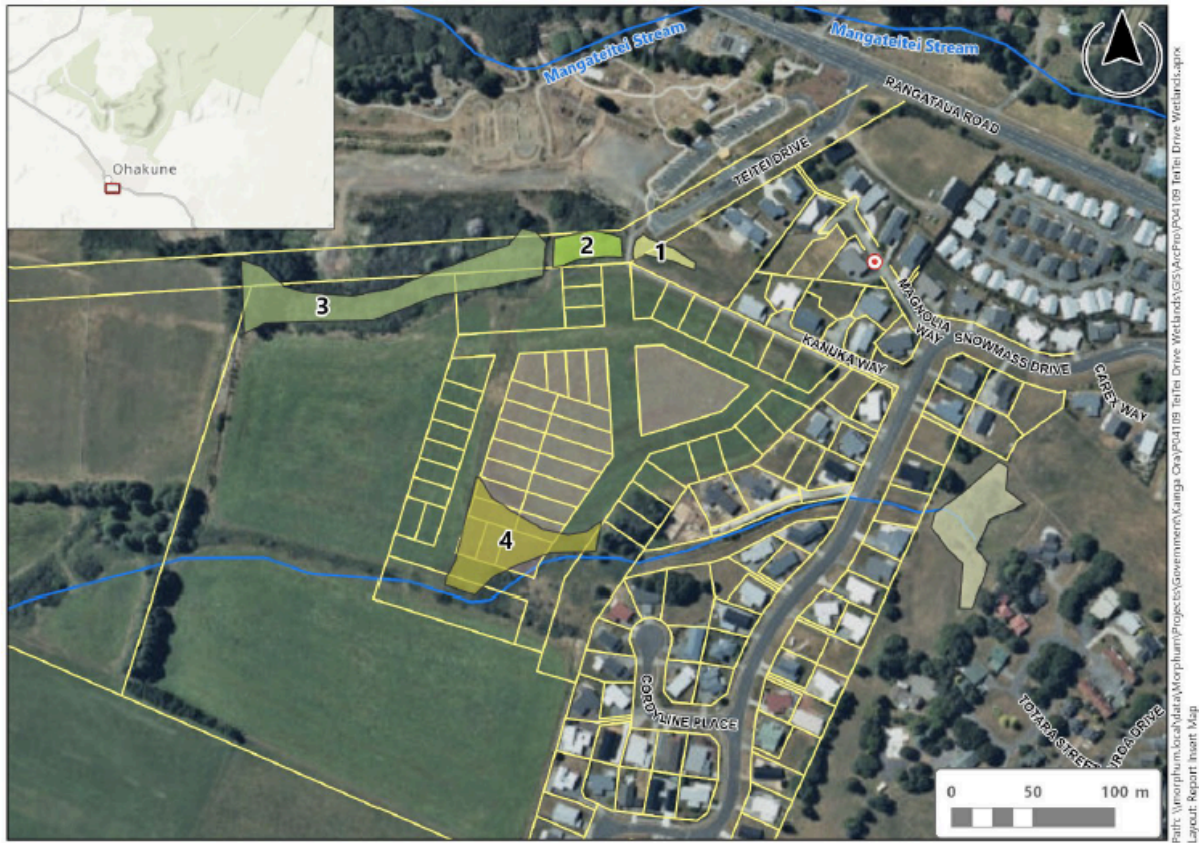
Figure 9 - Morphem Environmental's site map outlining discrete wet/boggy areas to assess and delineate.

- The larger reach beyond the footpath and heading downstream (areas 2 and 3 in *Figure 9* and blue polygon in *Figure 10*) has been partly assessed by Morphem Environmental. The section of wetland that may be impacted by Stage 1 of the development is labelled as '2' in *Figure 9*. Morphem have confirmed that this is a **natural inland wetland** in the map provided in their wetland assessment report (*Figure 11*). The area will also need to be assessed against the NES-F. Large pools of standing water (at least 30cm deep in places) were present under willows and sub-canopy plants.

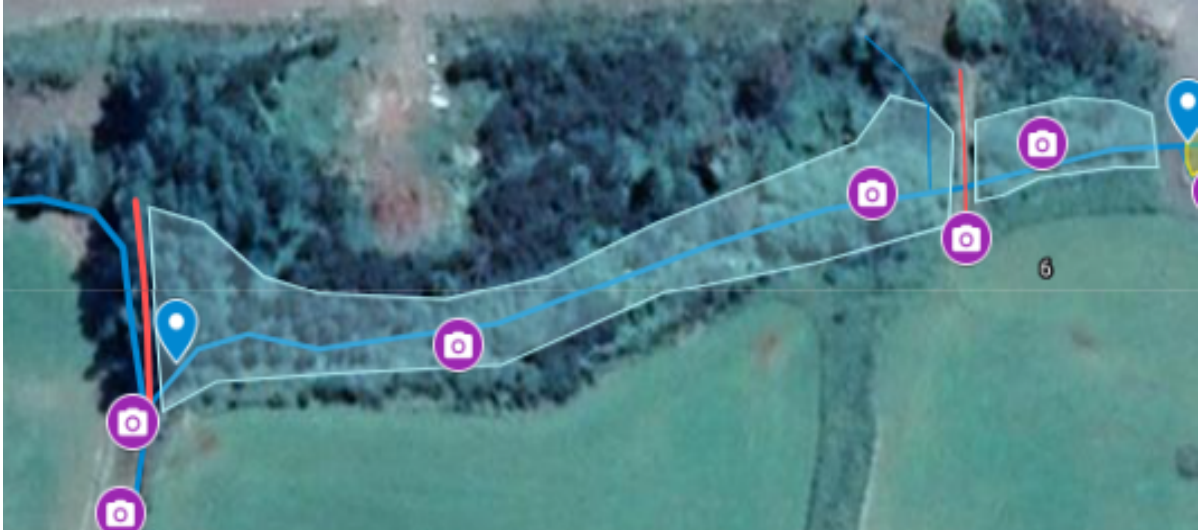
Figure 10 - Zoomed-in map view of approximate wetland area

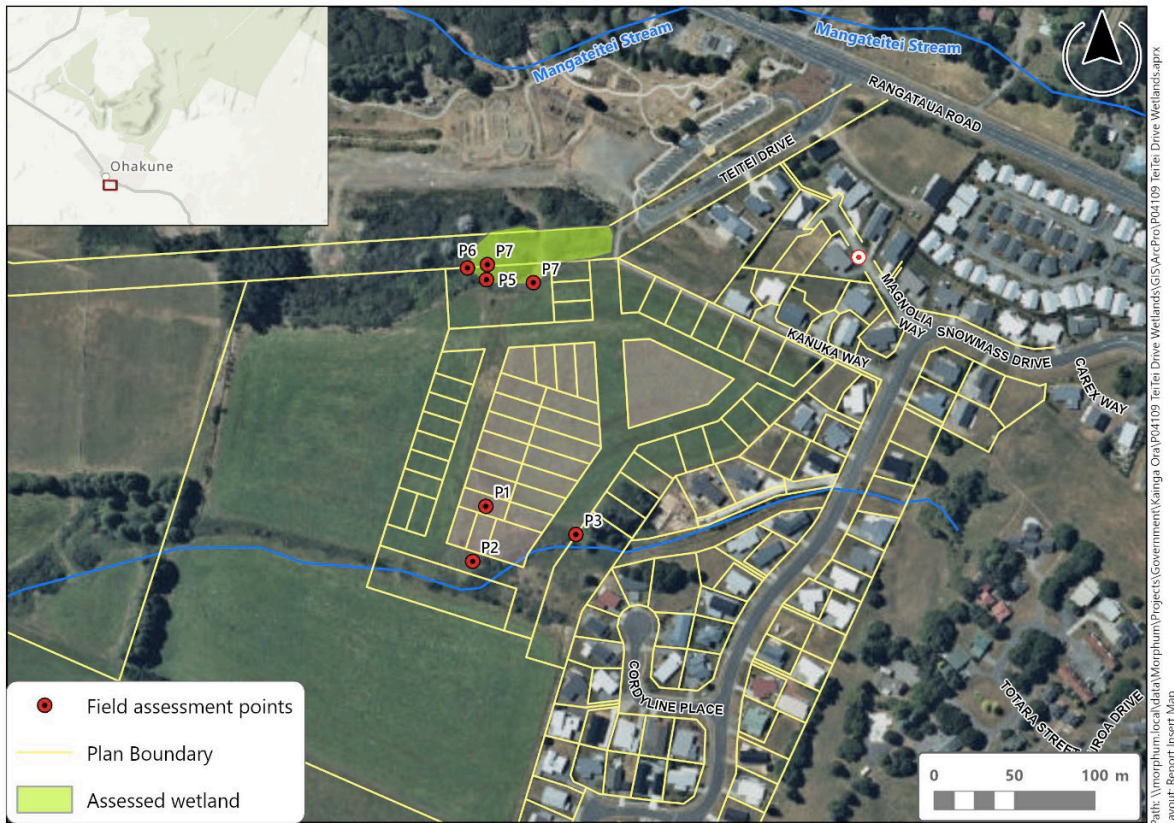
Figure 11 - Assessed wetland area on site and location of assessment points. Source: Morphum Environmental

- The wetland area is well shaded (in summer) throughout, with some regenerating natives (including mānuka) but also several weed species such as willows, blackberry and broom.
- Blackberry and wasps limited access to some parts of this area.
- There is no obvious connection (i.e. culvert or confluence) to the modified stream (waterway C) between Rochfort Park (to the west) and the site. This appears to be bunded and cut off (perhaps by the formation of the drain around sports fields) so drainage from here would likely be through soakage to ground and overland flow (confirmed by Cheal in their hydrology report and *pers. comm.* with Ray Kilgour).

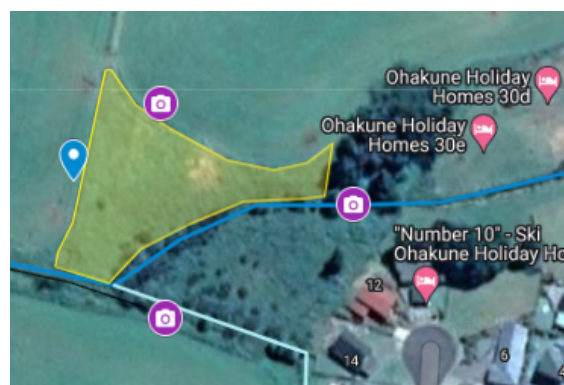
- We were unable to sample for eDNA from this reach due to inaccessibility and poor sampling conditions.
- There are wetland/wet-feet loving plants present in the large unmown/triangular area adjacent to the stream (shown in *Figure 13* on the [MyMap](#) as the larger yellow polygon mid-site). This appears to act as a floodplain/flood water retention area and was assessed by Morphm Environmental for wetland attributes. The vegetation complex was inconclusive in determining wetland status (facultative species). The absence of hydric soils (soil types associated with wetland/inundation) and wetland hydrology confirmed that this area was not a Natural Inland Wetland <sup>14</sup> for NES-F purposes. It may yet have other values and statutory protections which the project will have to clarify.

*Figure 13 - Zoomed-in map view of floodplain retention area*

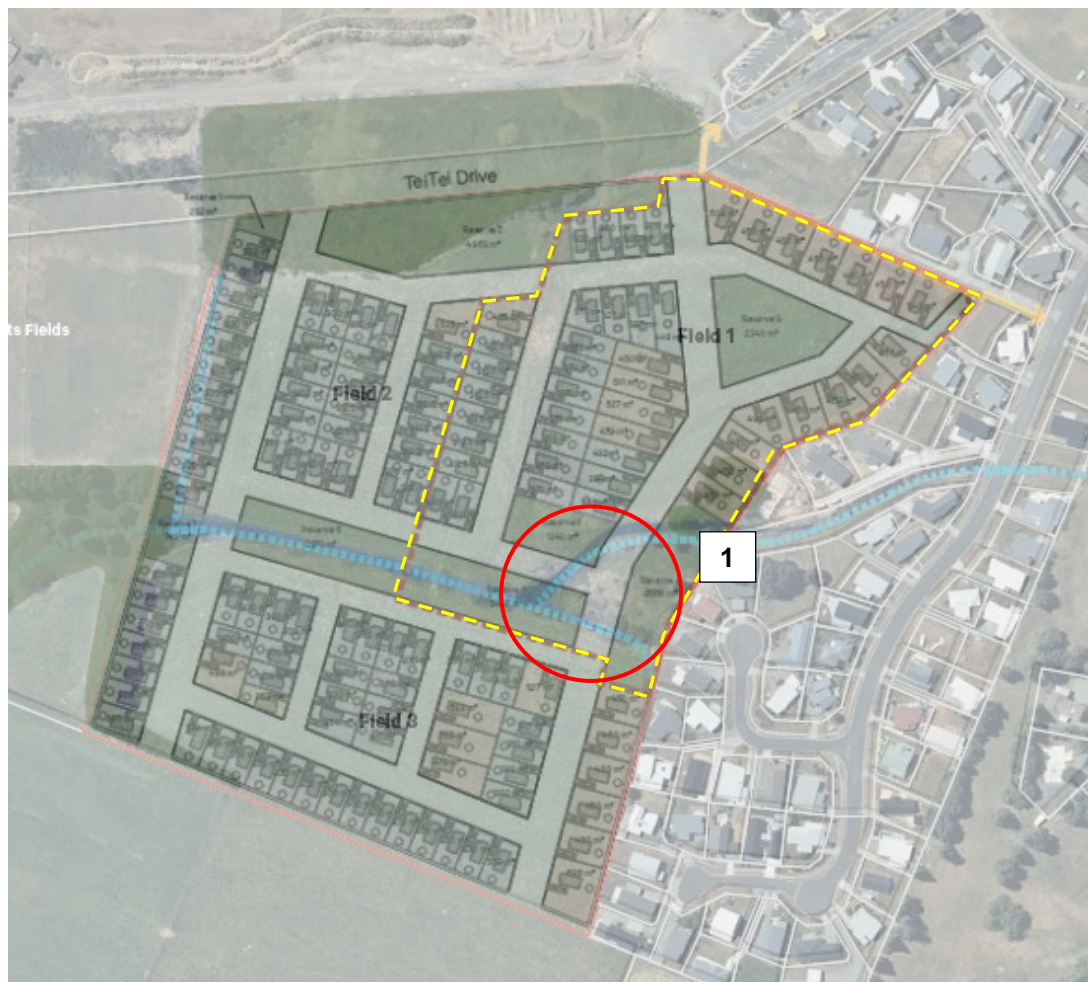
We have assessed the effects of Stage One of the development on streams within Stage One. This is shown in *Figure 14* below.

*Figure 15 - Site development overlay with current site conditions underneath, red circles denote areas that will need detailed planning to address effects on streams. Stage 1 shown as yellow dashed line.*

Two sections of stream (Waterway B and a small low-flow tributary) will be culverted to form roads in Stage One of the development.

- There will be stream extent loss with associated groundworks/earthworks and disturbance of approximately<sup>16</sup>
  - 58m and 116m<sup>2</sup> (based on an average 2m width) for Waterway B and;
  - 25m and 37.5m<sup>2</sup> (based on 1.5m average width) for the small tributary.
- Changes to stream flows through creation of impervious areas and riparian habitat loss as a result of road and pavement formation, and culvert installation. Flows after rain events will have higher velocities and therefore more chance of causing stream bed and bank erosion.
- Changes to bed and banks of stream upstream and downstream as part of culvert installation earthworks.

- Conducting works in summer months where stream flows are low or not flowing and according to industry best practice guidelines.
- Installation of larger diameter culverts, embedded by 25-50% of culvert height with appropriate water depths (150mm for native fish passage) and with elements (such as baffles) to provide flow diversity within the culverts according to the New Zealand Fish Passage Guidelines<sup>17</sup>
- Ecological restoration of up and downstream of impact site.
- Reinststate meanders and some sinuosity downstream by adding large woody elements to recreate or improve flow diversity (pools, riffles, runs).
- Reinststate and rebatter stream banks impacted by earthworks.

- Install a temporary stream bypass during culvert installation to maintain fish passage.
- Plan for and implement an active fish and kōura salvage prior to and during instream works. This should be done in summer when flows are at their lowest (base flow).
- Maintain flow natural in stream at all times.
- Retain native riparian trees where possible.

- Use best practice methods and specifications for sediment and erosion control, and earthworks in and around waterways.
- Replant with ecosourced natives along all riparian areas onsite to a buffer width of at least 10m on each bank for the remainder of Waterway B, upstream and downstream (approx. 250m total)
