# Teitei Drive Wetlands

## Ecological Impact Assessment

**Final**

Prepared for Kaianga Ora

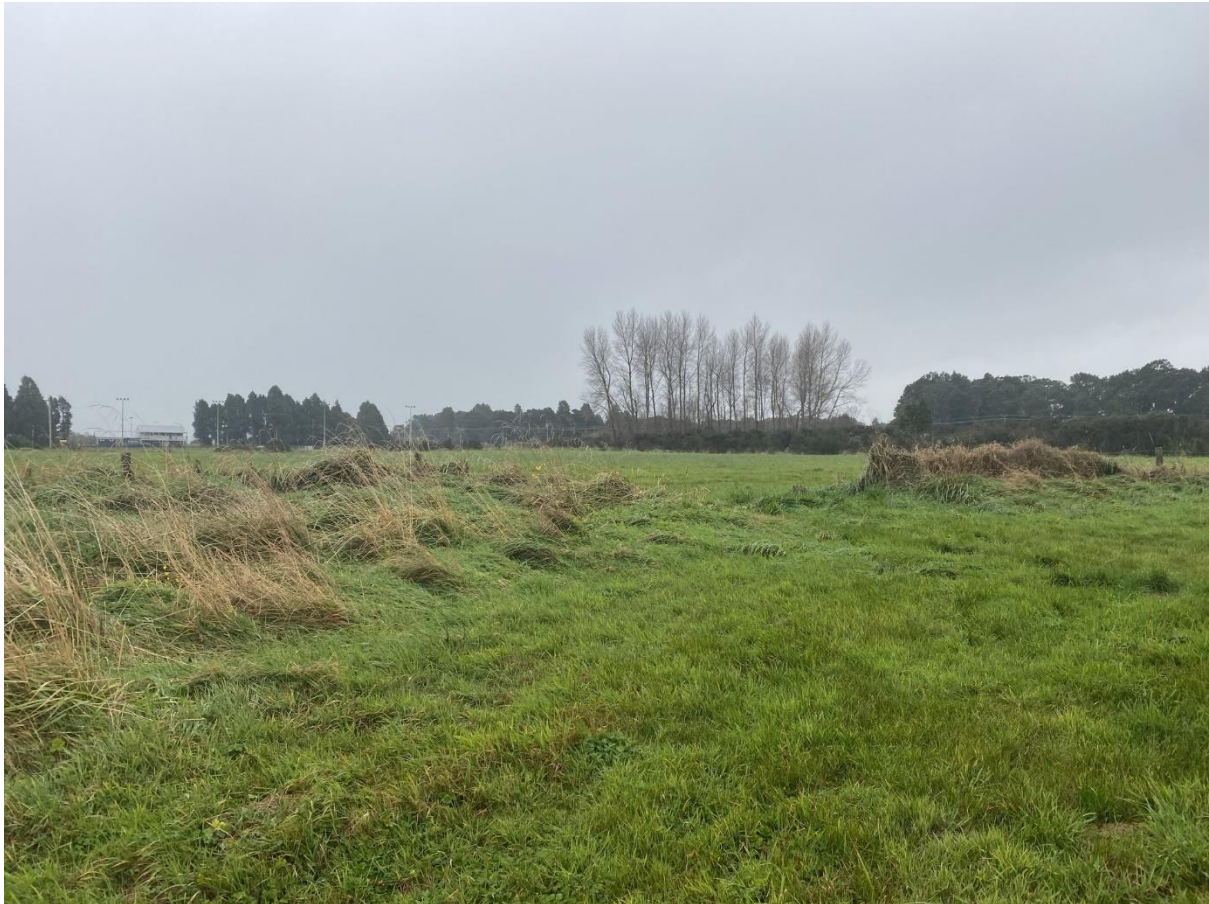
Figure 2: Proposed development site looking from the southeast corner to the northwest.

The site does not appear to have been used for stock grazing, but rather is used to cut hay/silage (Figure 2, Figure 3). The site has well established pasture grasses with silage pit areas on the central fence-line running north-south. Areas of the site remain uncut either due to proximity to waterways or for an apparent presence of a plant unpalatable to stock.

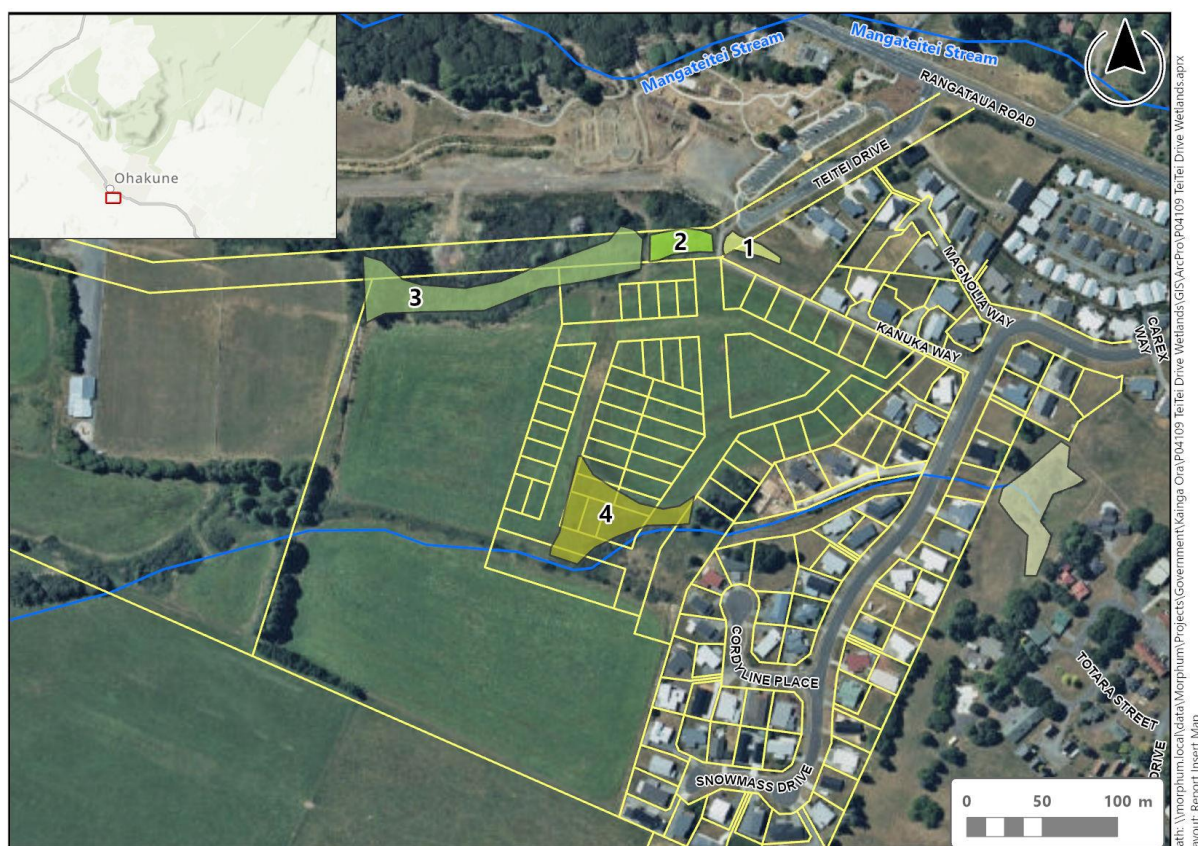
Figure 5: Potential wetlands for further assessment as identified by Kahu.

Preliminary ecological assessments by Kahu had identified 4 potential wetland areas on or close to the site (Figure 5). Three of these are along a watercourse/gully system forming the northern boundary of the site and the fourth is in the south of the site (Figure 5).

Potential wetland 1 (Figure 5) is likely a wetland. This is upstream of the site and more than 10 m for expected earthworks. As such it is not considered likely to impact the works, and the works are unlikely to affect the hydrology of this wetland. Further assessment was not undertaken to confirm its wetland status or determine whether it is constructed or a natural wetland.

Potential wetland 2 (Figure 5) was noted as a flooded gully area downstream of the culvert under the access path to the site. There was a mix of exotic species here including willows (*Salix* spp.) and blackberry (*Rubus fruticosus*). The pasture grasses on the edge of this area were flooded at the time of our site visit. There were areas that indicated sustained inundation and pooling of water, indicating a wetland using the hydrology tool. There is an access track separating wetland areas 2 and 3 which did

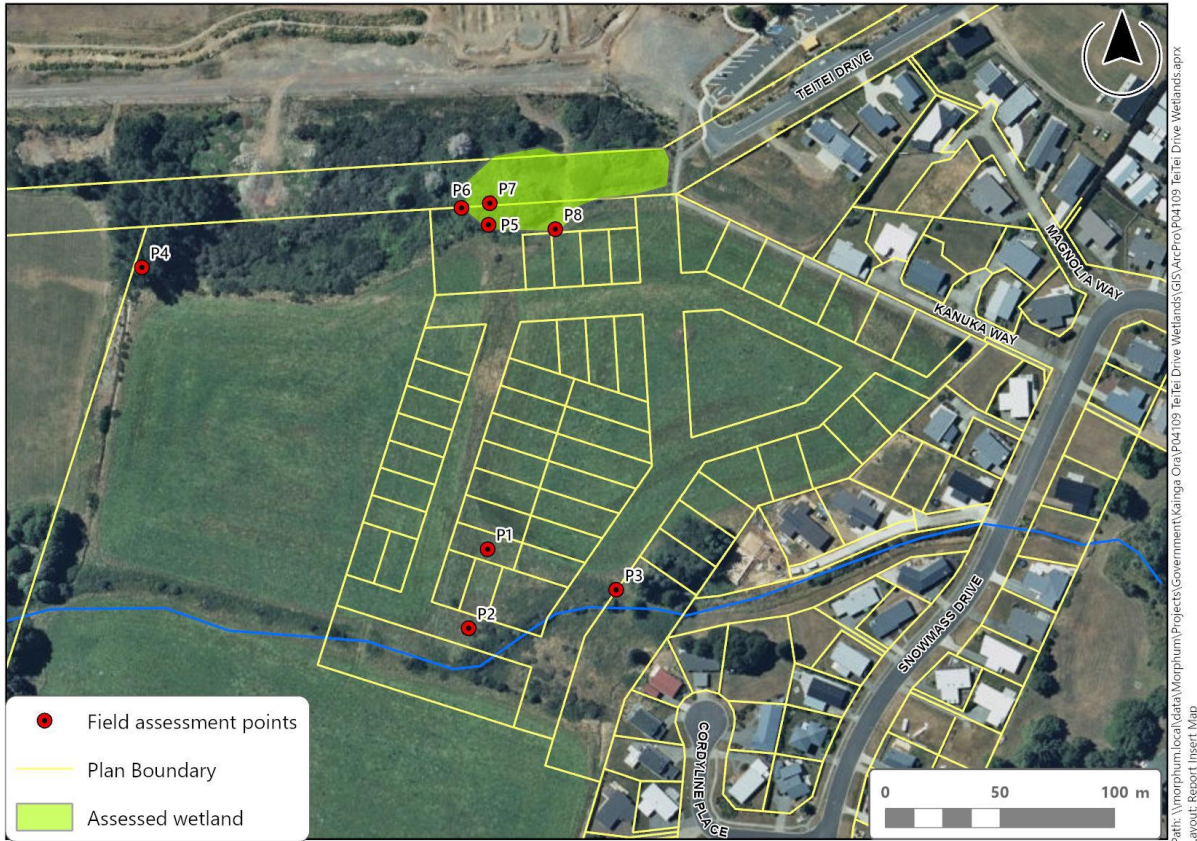
Figure 6: Wetland assessment points and area assessed as wetland (point 7 in standing water and points 5, 6 & 8 denote the edge of the wetland. Points 1 to 4 no wetland was found).

This wetland area was delineated primarily using the wetland hydrology present, and supported with hydric soil assessments; this is shown in Figure 6 with supporting assessment points (P5 to P8).

Wetland 3 was followed downstream where the surface water disappeared. Following the watercourse was restricted by the dense vegetation and, as such, there is uncertainty as to the fate of this water flow. Further assessment may be required. It was noted that there were dry soils in the gully at the western extent of potential wetland 3 (point 4, Figure 6).

The northern gully area was irregular at the western end (point 4, Figure 6) and it is suggested that this area may be an old waste fill area. Historical imagery from Retrolens<sup>1</sup> shows a railway line existed near this location and that there is likely to have been earthworks and other land transformation activities at this location in the past (Figure 9). There is currently no railway in this location.

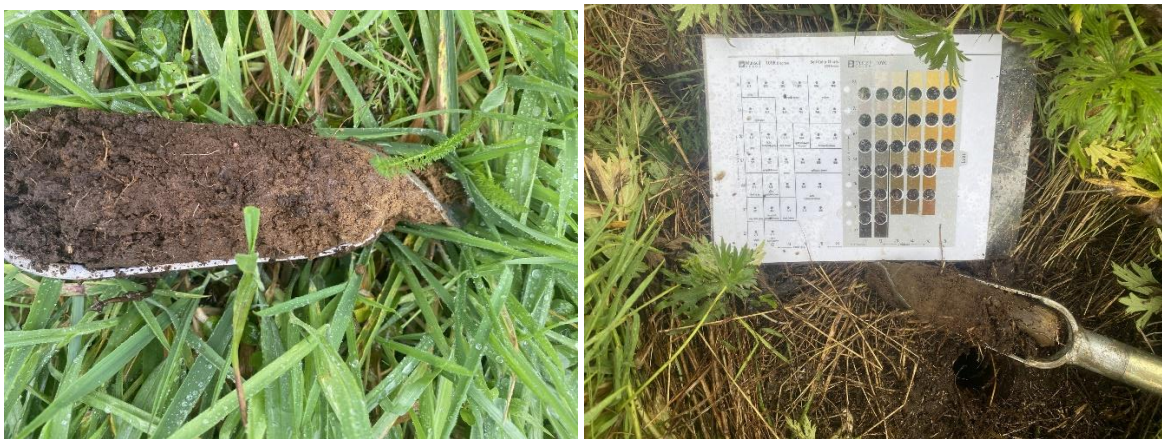
Figure 7: Soils in potential wetland area 4 illustrating dry lower horizon and red colours.

The potential wetland 4 site was slightly downslope, and a stream bordered one side, however, there were no indicators of inundation. Soil augers were undertaken in three locations (points P1, P2 and P3, displayed in Figure 6). The soils were damp near the surface (due to dense vegetation), but dry and friable at a depths of 150 to 300 mm with a colour indicating there was no gleying (Munsell 10YR 5/4) (Figure 7). No mottles were present. This indicates that this area is not a wetland as it lacks wetland hydrology and hydric soils. It is likely that this area is vegetatively different from the rest of the paddock as it has not been mown and allowed to grow rank with resulting increased moisture in the vegetated matter.

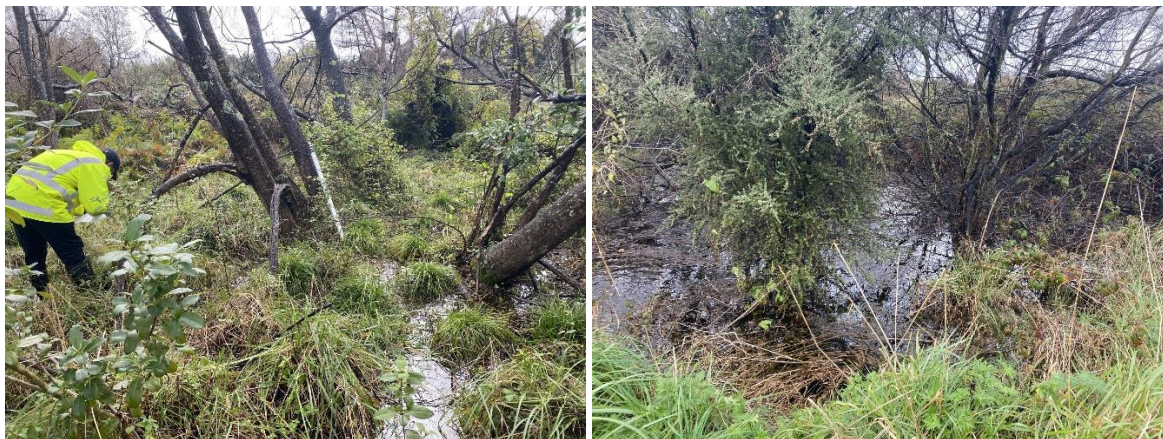
Figure 8: Potential wetland area 3.

Potential wetland 3 is immediately downstream of wetland 2. It was also flooded into the pasture grass edge at the time of the site visit (Figure 8). Vegetation is similar to wetland 2 and based on the evidence of regular flooding and very wet soils, this too is considered a **natural wetland under the NES:F**.
